**1997 Thomas Built Bus  
into a Flat Frontal Barrier  
TRC Test Number: 990421-1**

**Prepared by:  
Transportation Research Center Inc.  
10820 State Route 347  
East Liberty, OH 43319**

**Final Report  
April - June 1999**

**Prepared For:  
Vehicle Research and Test Center  
P. O. Box 37  
East Liberty, OH 43319**

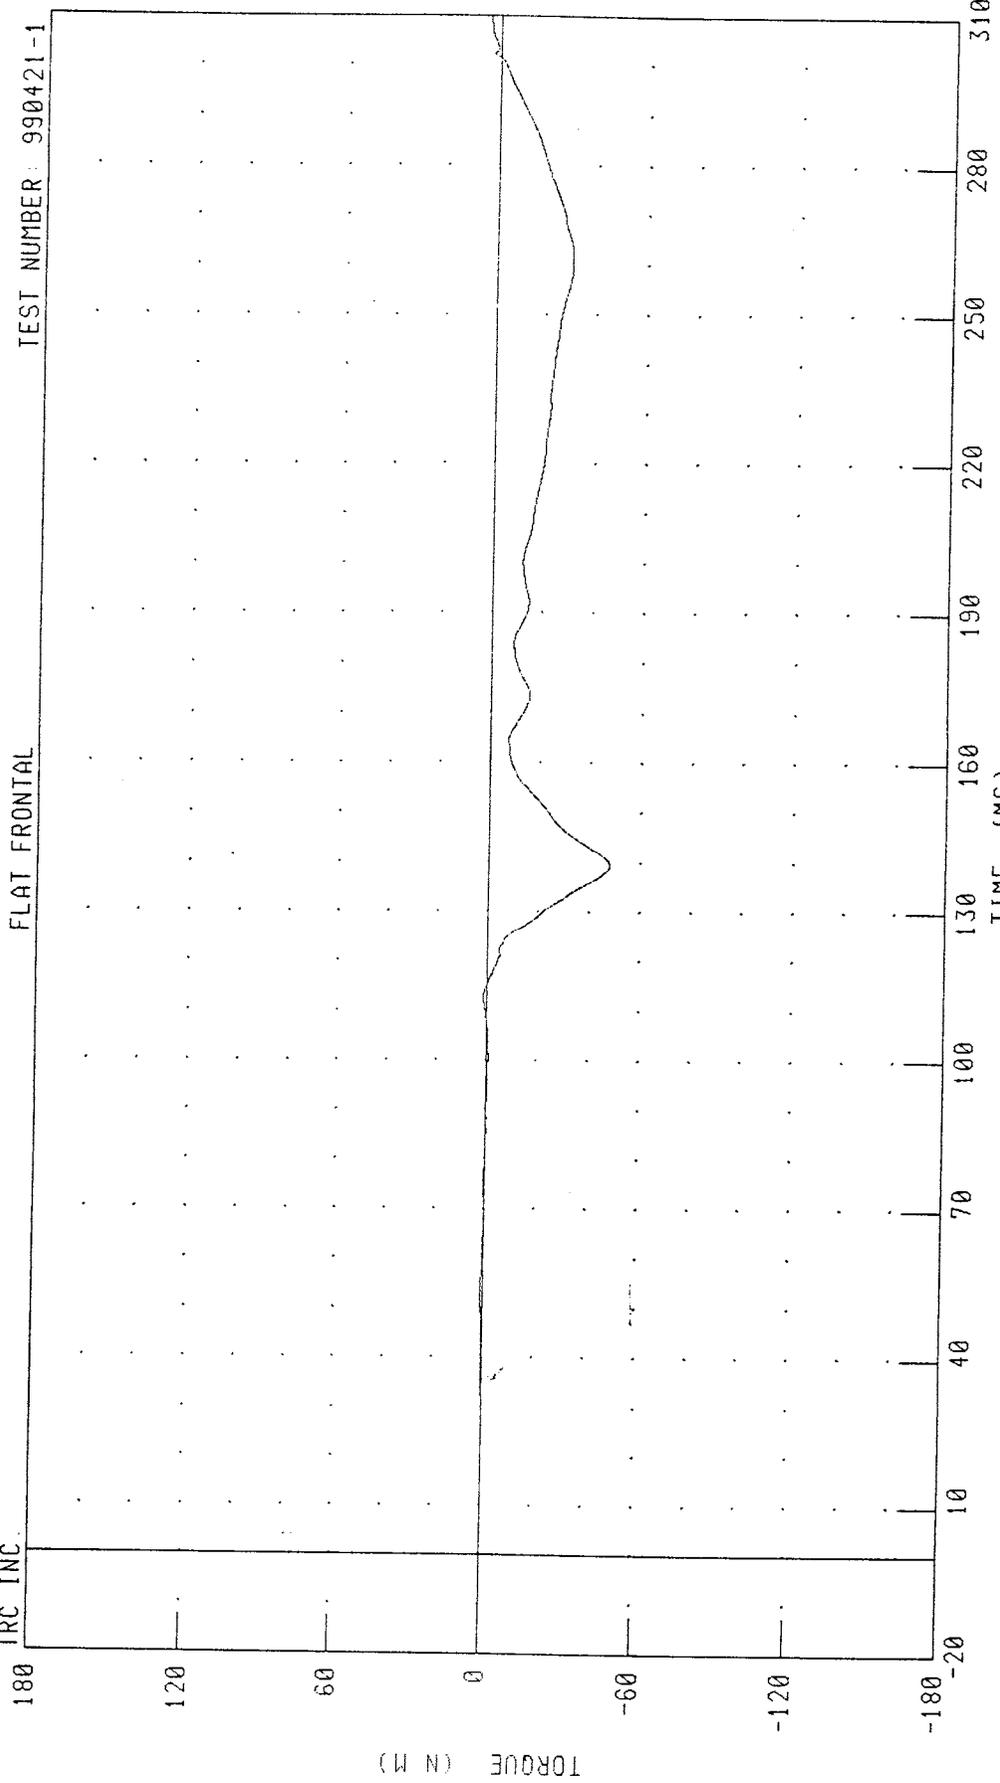
CHANNEL: NEKXMI

FILTER: CH. CLASS 600

PEAK DATA: 3.86 N.M @ 309.76 MS; -47.92 N.M @ 139.60 MS

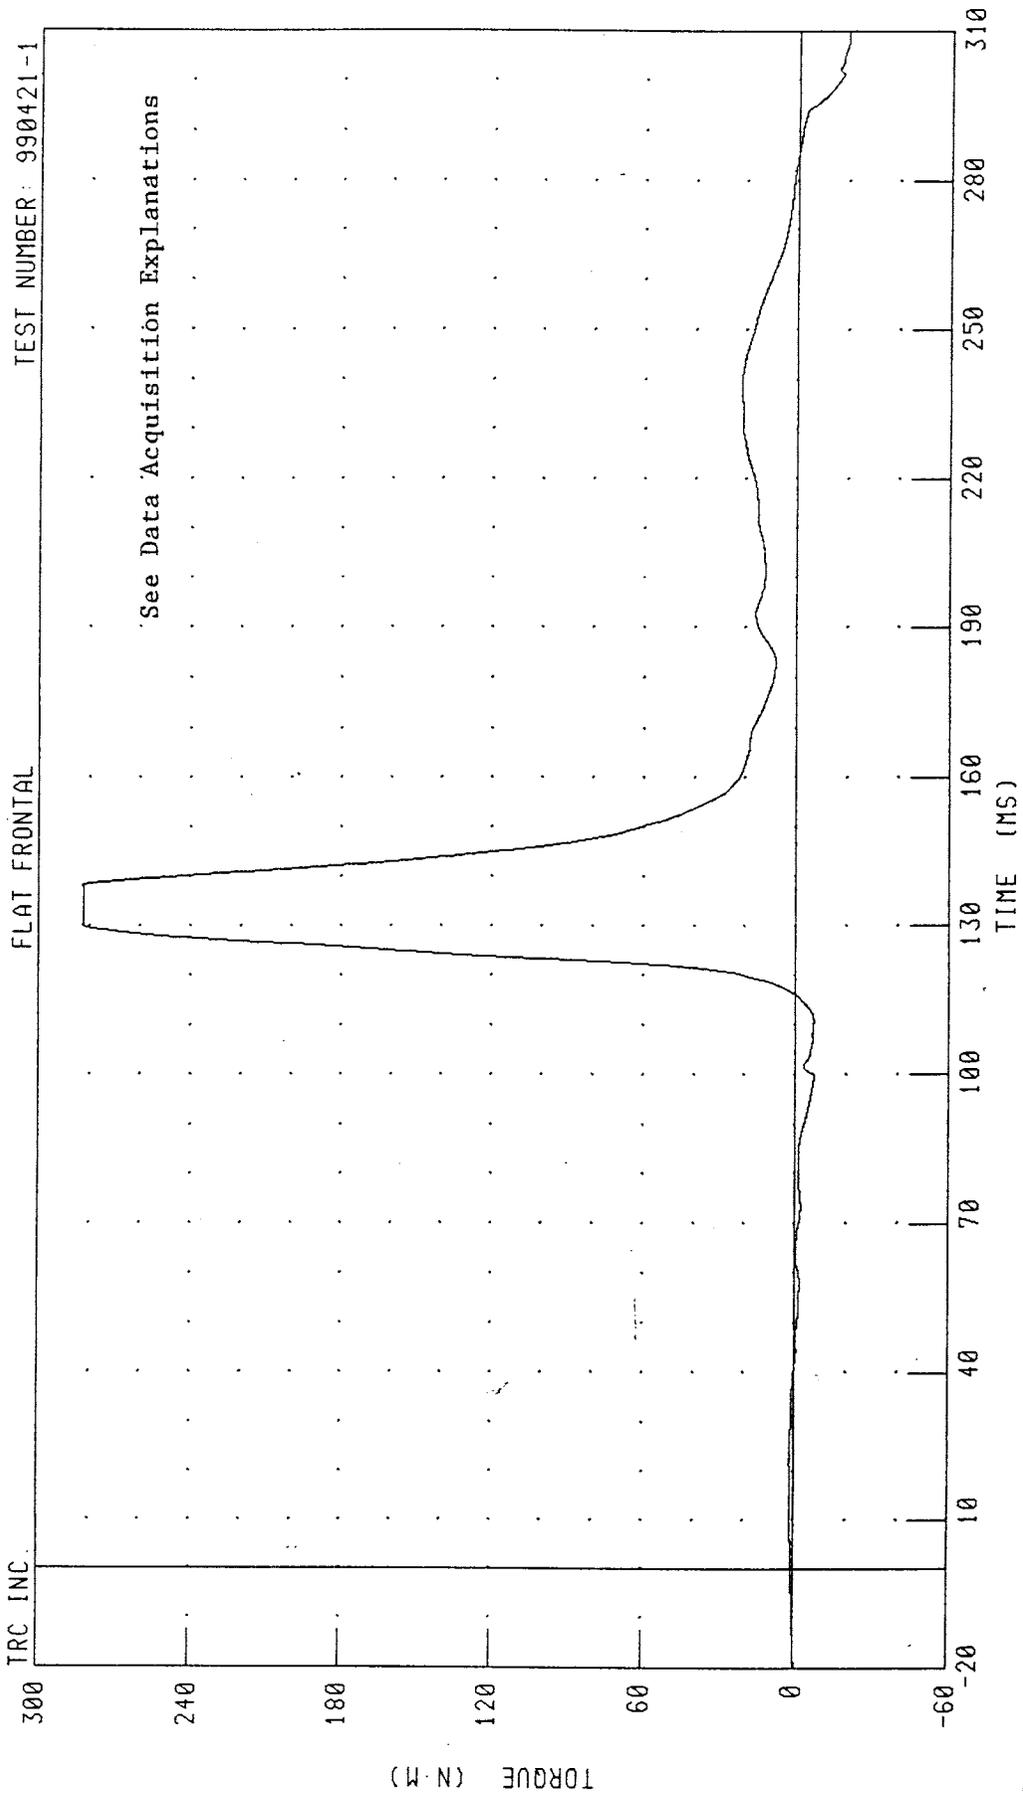
1997 THOMAS BUILT BUS INTO FLAT FRONTAL BARRIER  
POSITION # 1 NECK MOMENT ABOUT Y AXIS  
FLAT FRONTAL

CHANNEL: NEKYM1 FILTER: CH. CLASS 600  
PEAK DATA: 282.71 N·M @ 138.32 MS; -19.62 N·M @ 309.68 MS

The Position #1 dummy's neck moment about Y-axis data channel, NEKYM1, exceeded its data channel's full scale input between approximately 130 and 140 milliseconds. This affected the calculation for the moment about the occipital condyle for the Position #1 dummy.

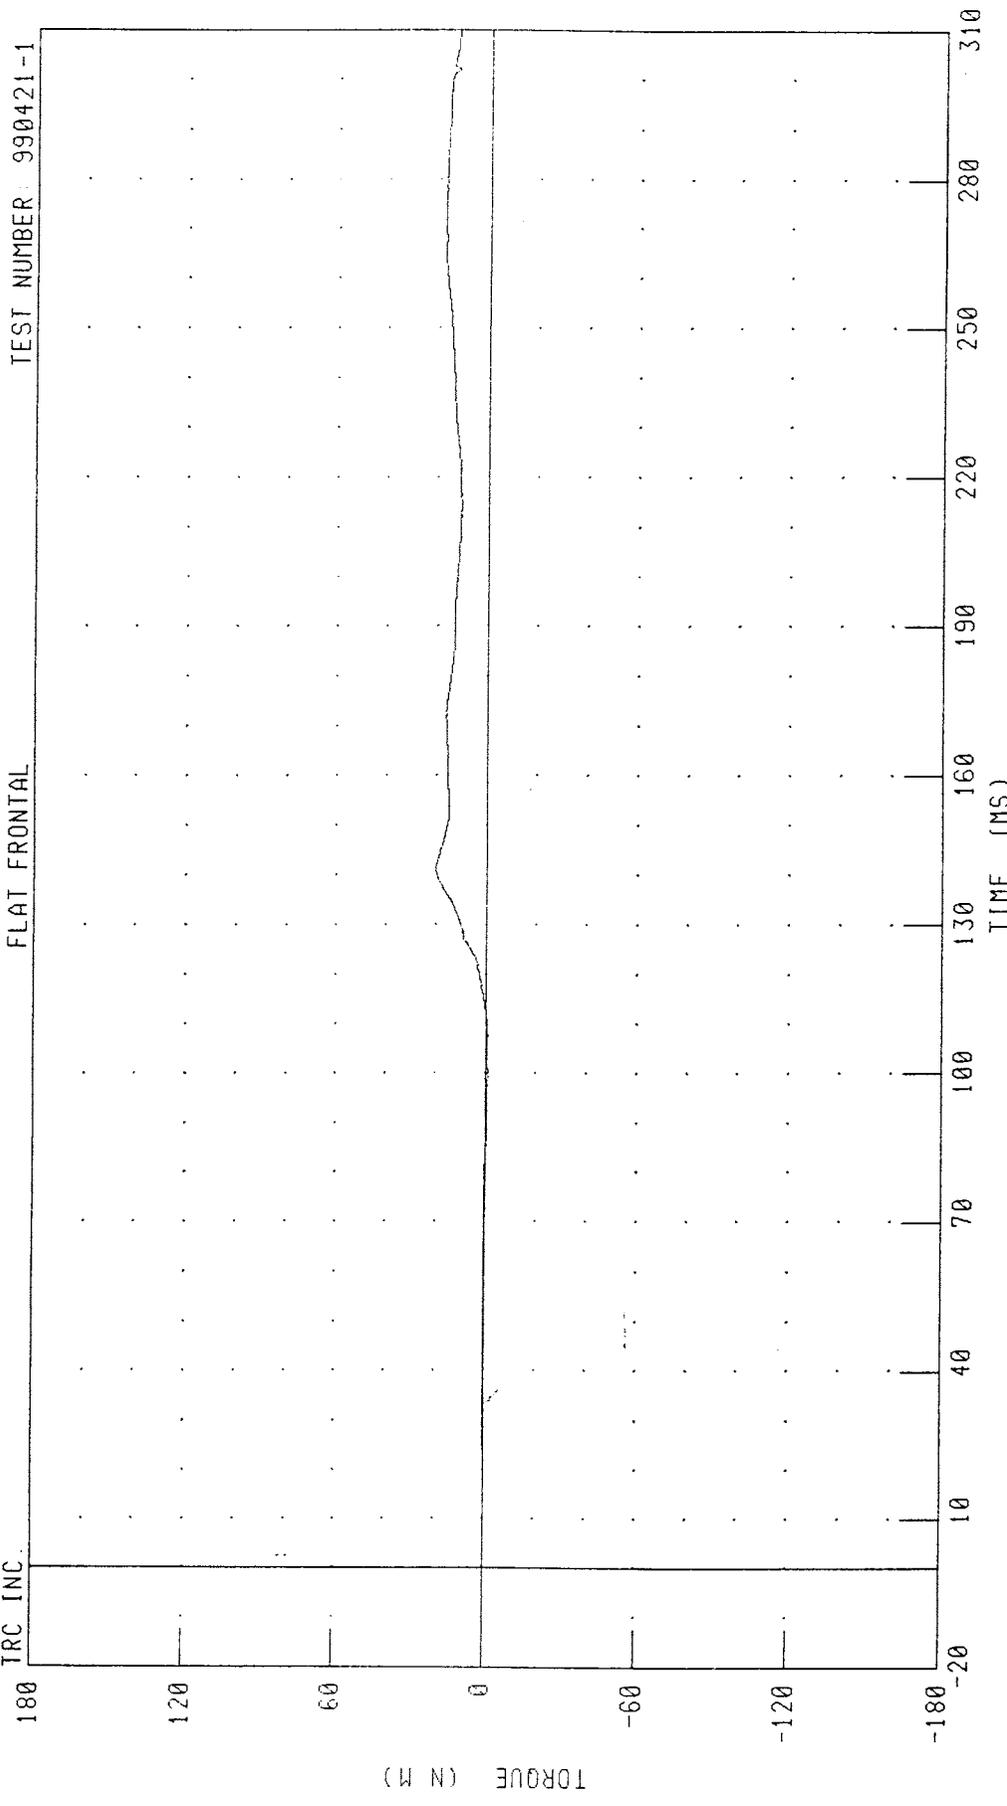
1997 THOMAS BUILT BUS INTO FLAT FRONTAL BARRIER  
POSITION # 1 NECK MOMENT ABOUT Z AXIS  
FLAT FRONTAL

CHANNEL: NEKZM1 FILTER: CH. CLASS 600  
PEAK DATA: 20.09 N.M @ 141.52 MS, -1.14 N.M @ 99.44 MS  
TIME (MS)

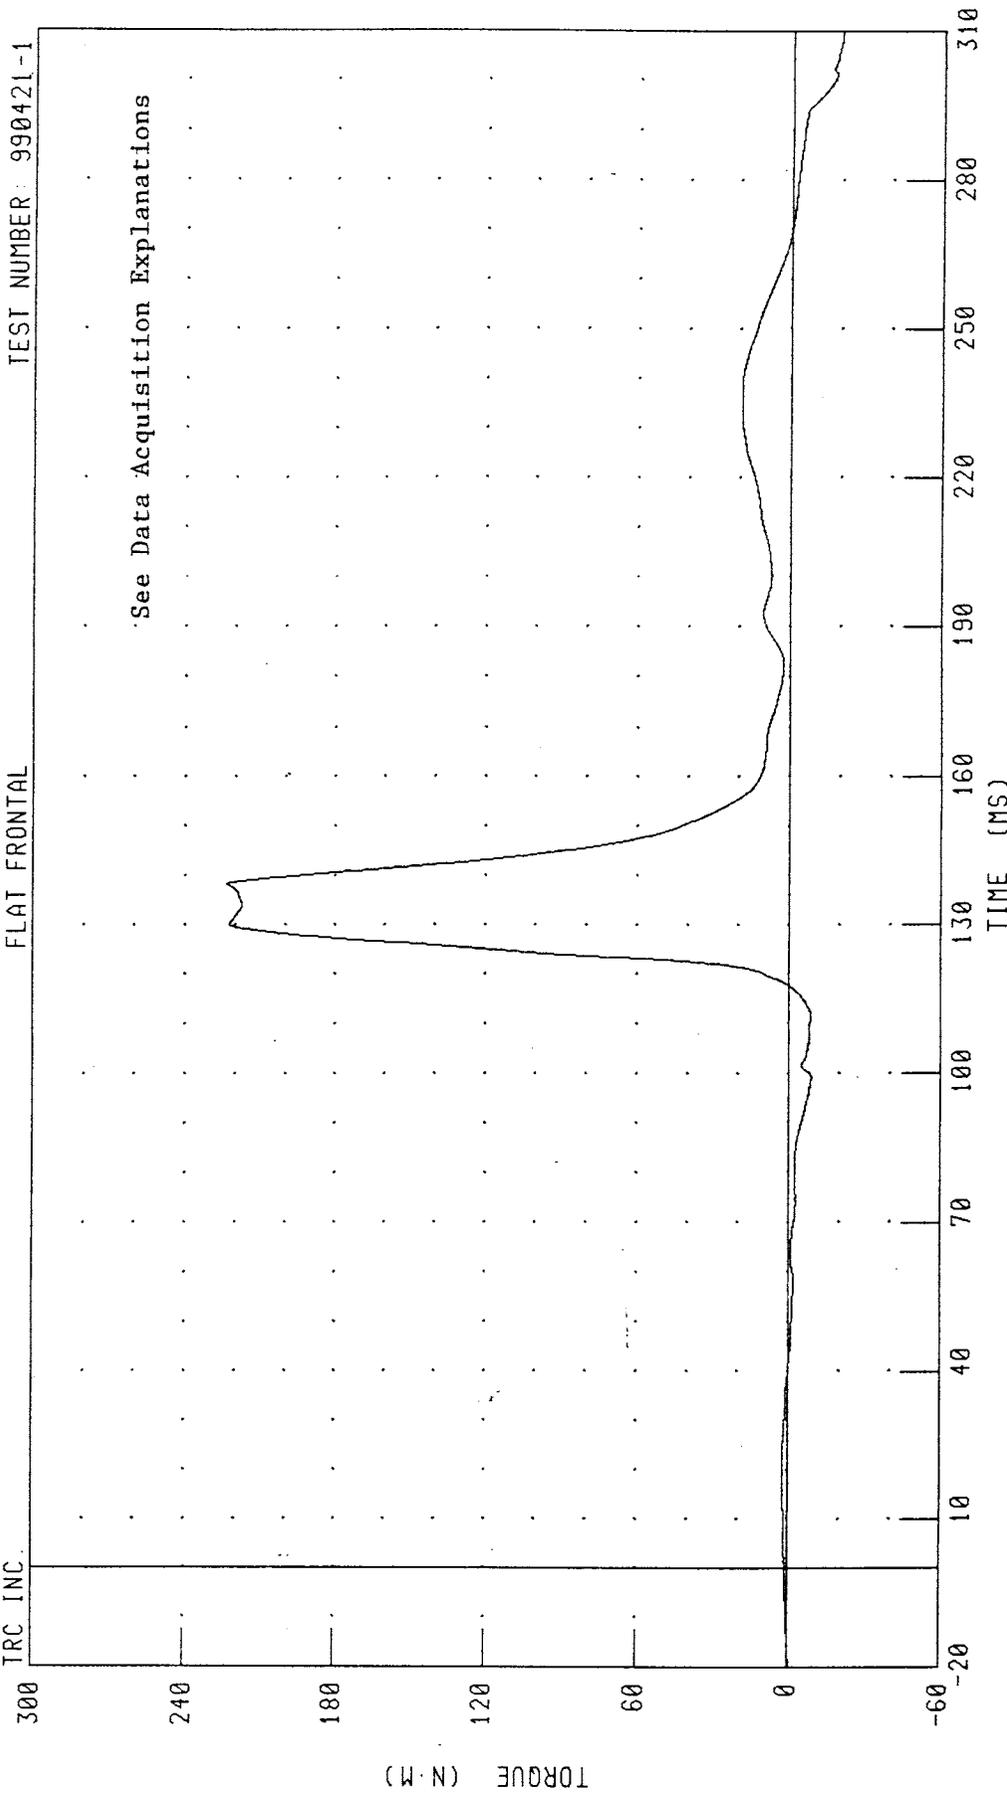
1997 THOMAS BUILT BUS INTO FLAT FRONTAL BARRIER  
POSITION # 1 NECK OCCIPITAL CONDYLE  
FLAT FRONTAL

See Data Acquisition Explanations

CHANNEL: NEKOM1 FILTER: CH. CLASS 600  
PEAK DATA: 223.57 N.M @ 138.40 MS; -19.42 N.M @ 309.60 MS

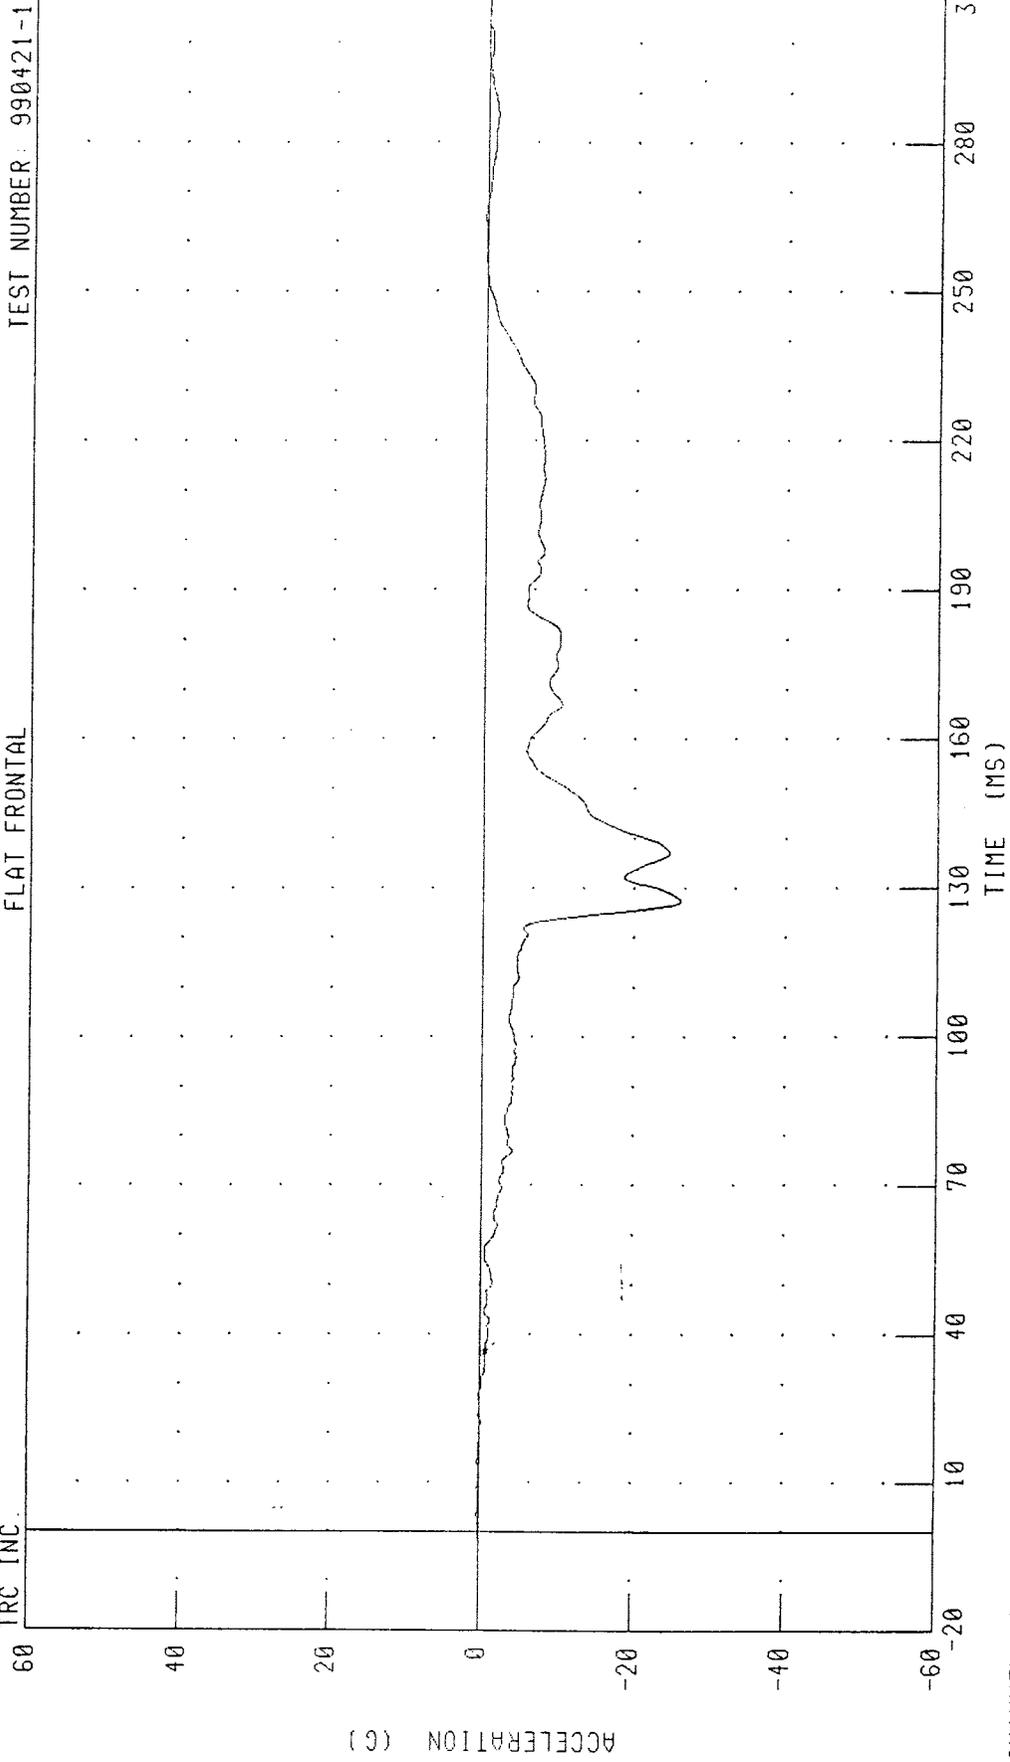
1997 THOMAS BUILT BUS INTO FLAT FRONTAL BARRIER  
POSITION # 1 CHEST X-AXIS ACCELERATION  
FLAT FRONTAL

CHANNEL: CSTXG1 FILTER: CH. CLASS 180 PEAK DATA: 0.22 G @ 14.24 MS, -26.16 G @ 127.44 MS

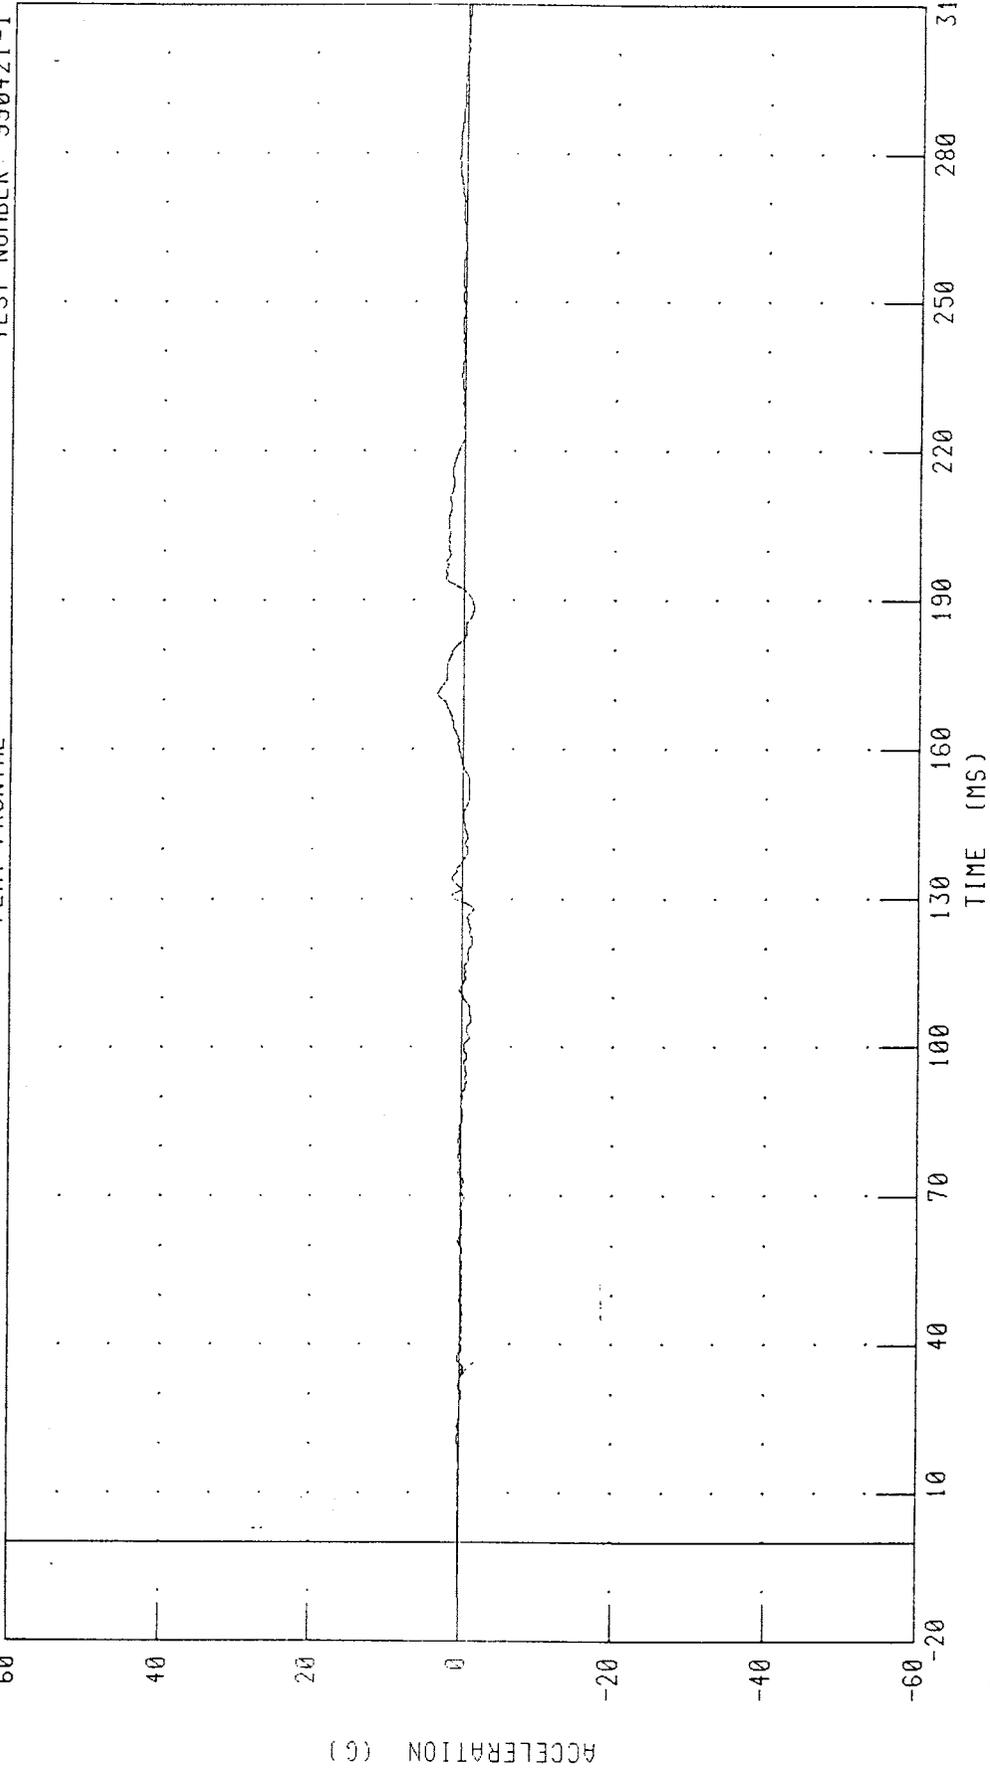
1997 THOMAS BUILT BUS INTO FLAT FRONTAL BARRIER  
POSITION # 1 CHEST Y-AXIS ACCELERATION  
FLAT FRONTAL

CHANNEL: CSTY61 FILTER: CH. CLASS 180 PEAK DATA: 3.43 G @ 171.20 MS; -1.61 G @ 128.16 MS

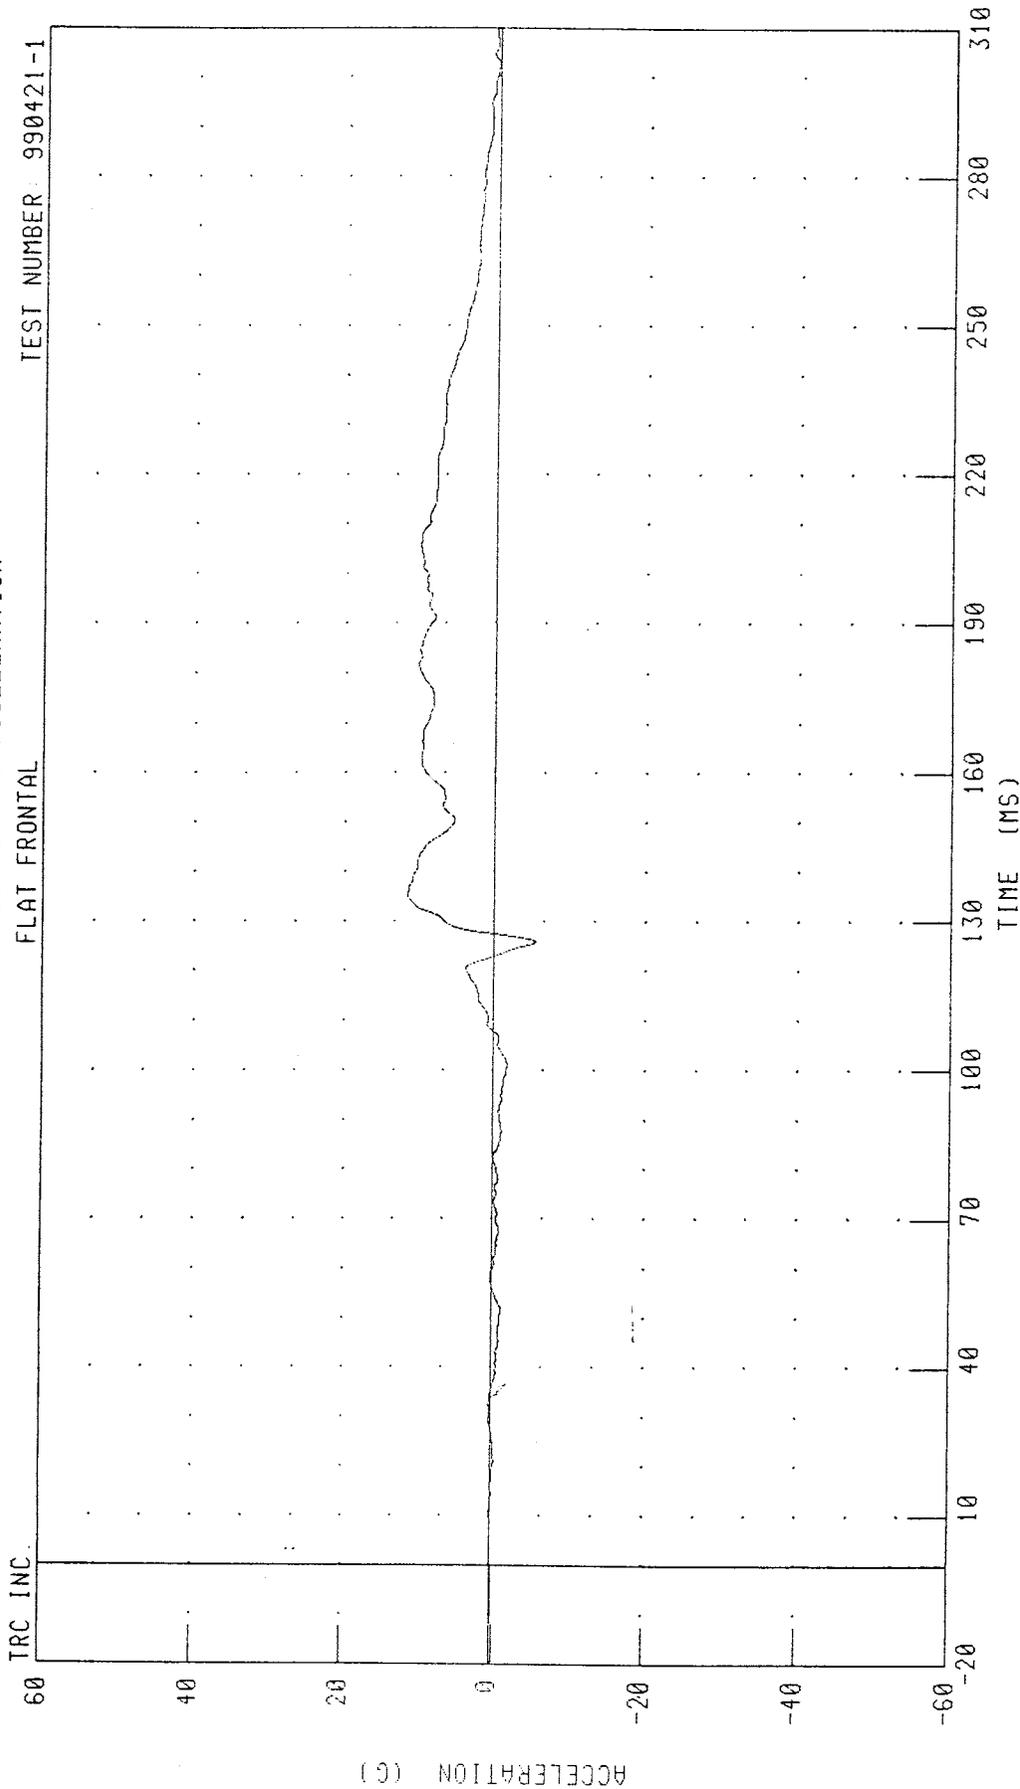
1997 THOMAS BUILT BUS INTO FLAT FRONTAL BARRIER  
POSITION # 1 CHEST Z-AXIS ACCELERATION  
FLAT FRONTAL

CHANNEL: CSTZG1 FILTER: CH. CLASS 180

PEAK DATA: 11.68 G @ 135.28 MS, -5.60 G @ 126.00 MS

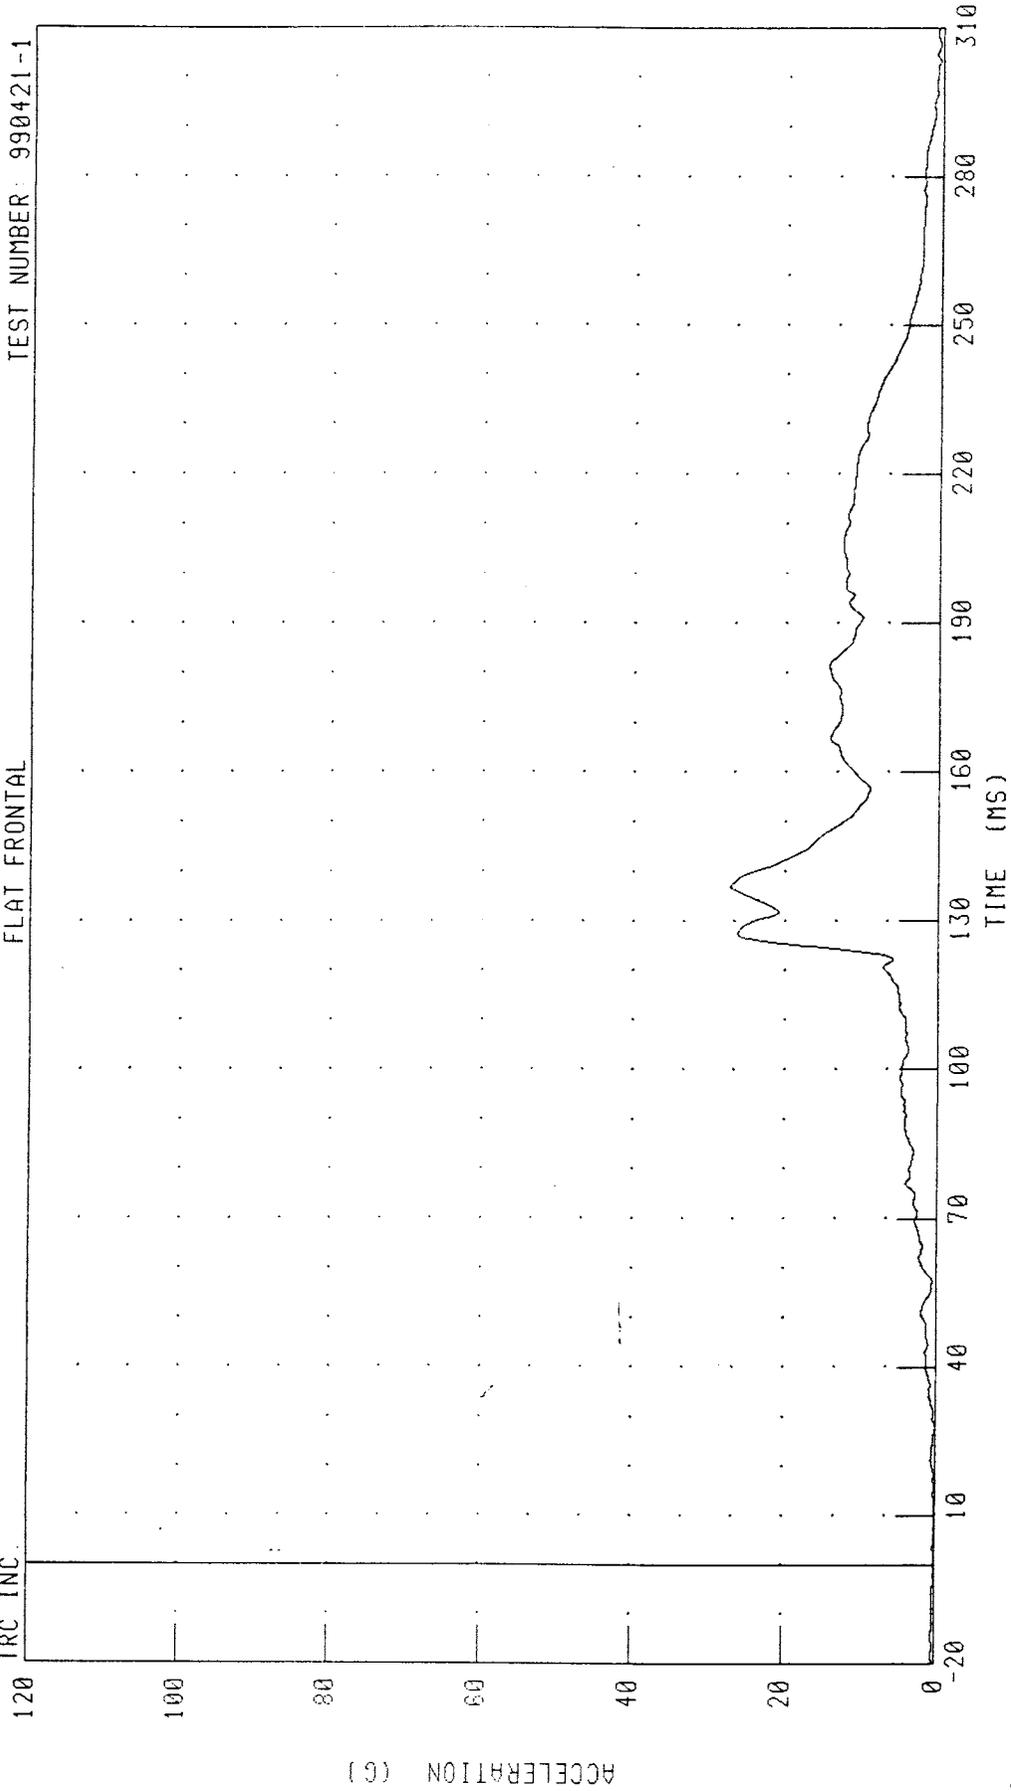
1997 THOMAS BUILT BUS INTO FLAT FRONTAL BARRIER  
POSITION # 1 CHEST RESULTANT ACCELERATION  
FLAT FRONTAL

CHANNEL: CSTRG1 FILTER: CH. CLASS 180

PEAK DATA: 27.18 G @ 137.12 MS, 0.03 G @ -20.00 MS

The Position #1 dummy's 36 milliseconds Head Injury Criteria (HIC) was 244. The Position #1 dummy's chest maximum resultant acceleration with three (3) milliseconds minimum duration was 26.0 g. The Position #1 dummy's chest deflection was 4 mm. The Position #1 dummy's left and right femur maximum compressive forces were 2704 N and 2708 N, respectively.

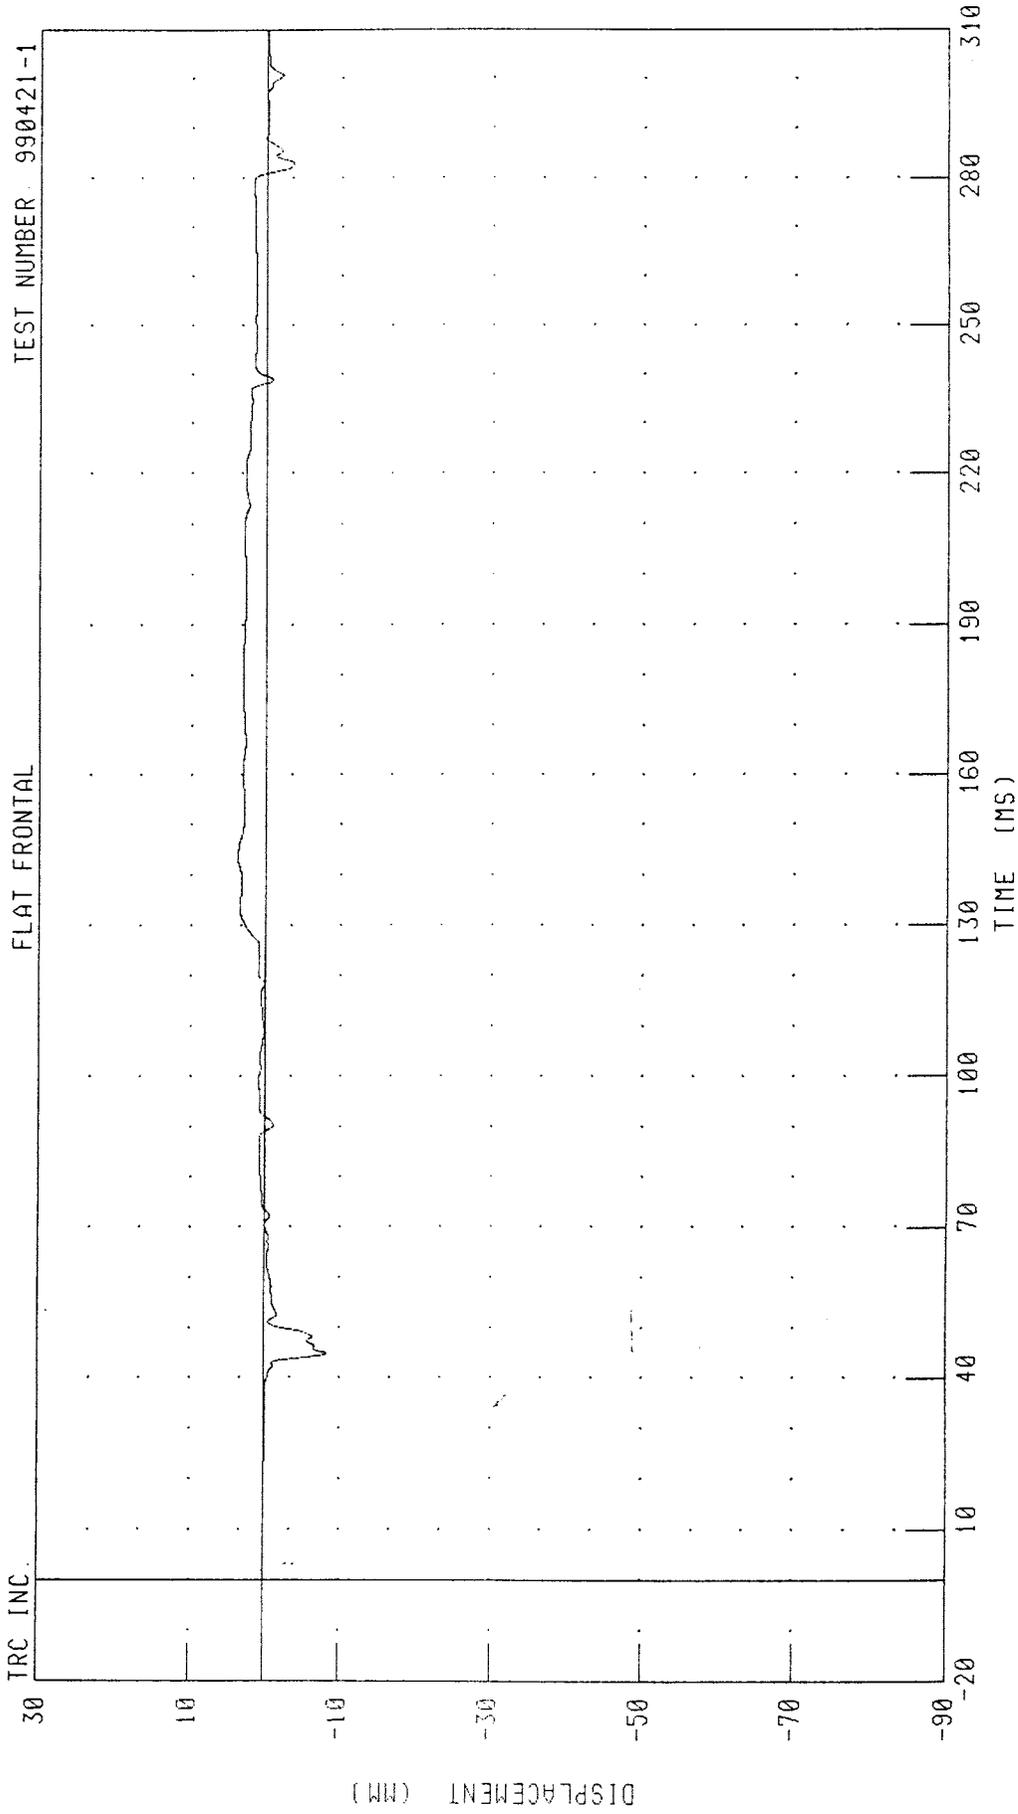
1997 THOMAS BUILT BUS INTO FLAT FRONTAL BARRIER  
POSITION # 1 CHEST DEFLECTION

CHANNEL: CSTXD1 FILTER: CH. CLASS 180

PEAK DATA: 3.80 MM @ 143.76 MS, -8.27 MM @ 44.96 MS

<u>Maximum Chest Deflection</u>	
Position #1 Dummy	4 mm

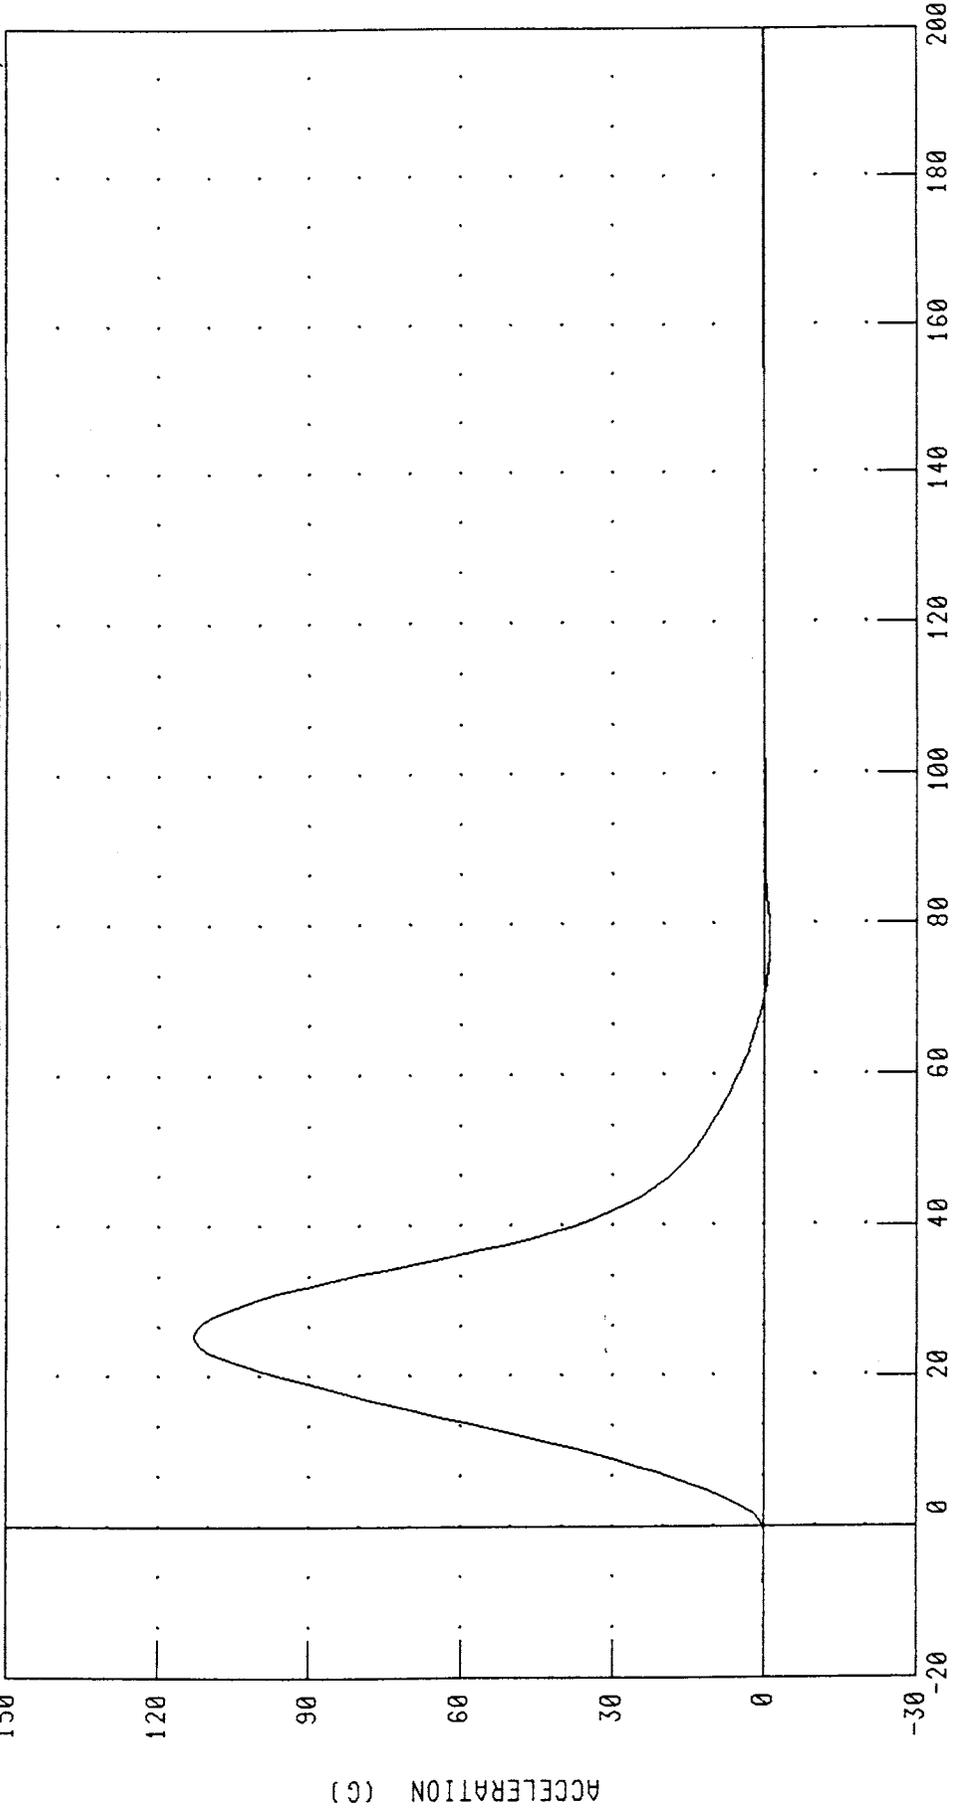
572E SN 90 RIGHT KNEE CAL 25

RUN NUMBER: 041599.0859.1

CHANNEL: PENXC FILTER: CH. CLASS 600

TEST PARAMETER	SPECIFICATION	TEST RESULTS
TEMPERATURE	18.9-25.6 DEG. C	21.1 DEG. C
RELATIVE HUMIDITY	10 - 70 %	33.0 %
PROBE VELOCITY	2.07 - 2.13 M/S	2.10 M/S
PEAK KNEE IMPACT FORCE 5.0 KG PENDULUM	4715 - 5782 N	5525.8 N

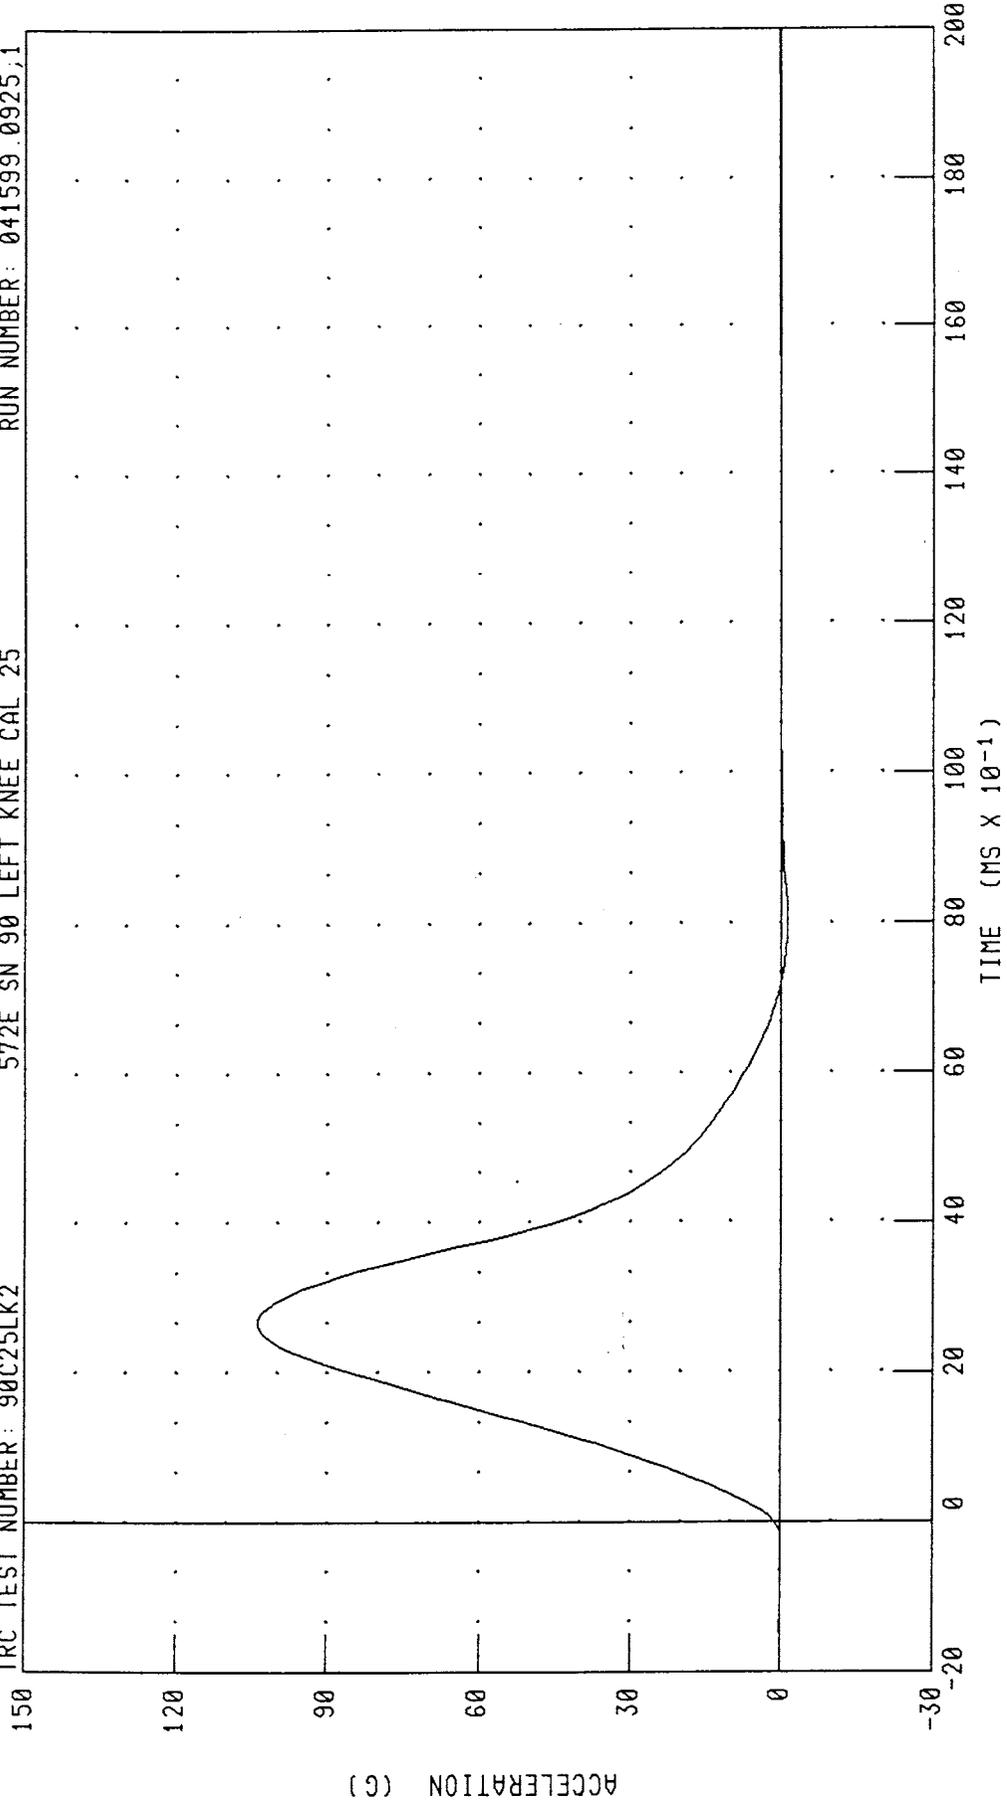
572E SN 90 LEFT KNEE CAL 25

CHANNEL: PENXG FILTER: CH. CLASS 600

PEAK DATA: 103.92 G @ 2.64 MS; -1.39 G @ 8.08 MS

TEST PARAMETER	SPECIFICATION	TEST RESULTS
TEMPERATURE	18.9-25.6 DEG. C	21.1 DEG. C
RELATIVE HUMIDITY	10 - 70 %	33.0 %
PROBE VELOCITY	2.07 - 2.13 M/S	2.10 M/S
PEAK KNEE IMPACT FORCE 5.0 KG PENDULUM	4715 - 5782 N	5084.5 N

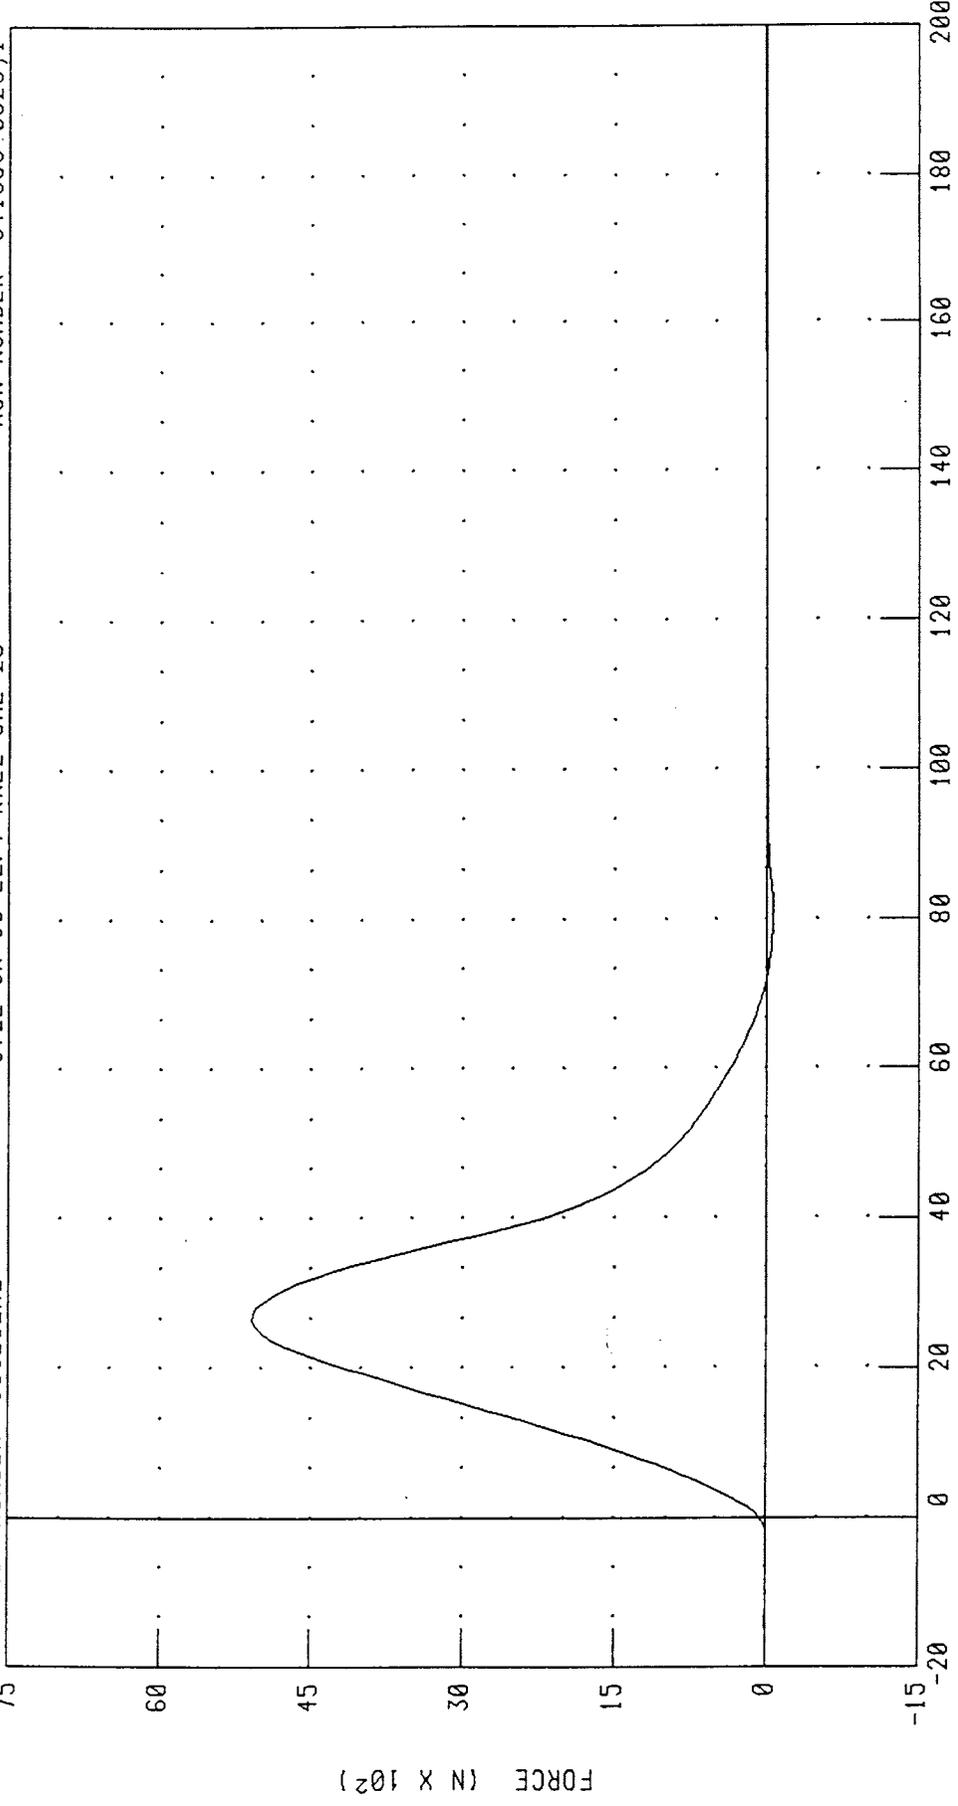
572E SN 90 LEFT KNEE CAL 25

CHANNEL: PENXF FILTER: CH. CLASS 600

PEAK DATA: 5084.57 N @ 2.64 MS, -68.20 N @ 8.08 MS
